An Taisce
The National Trust for Ireland

Buildings at Risk

November 2014

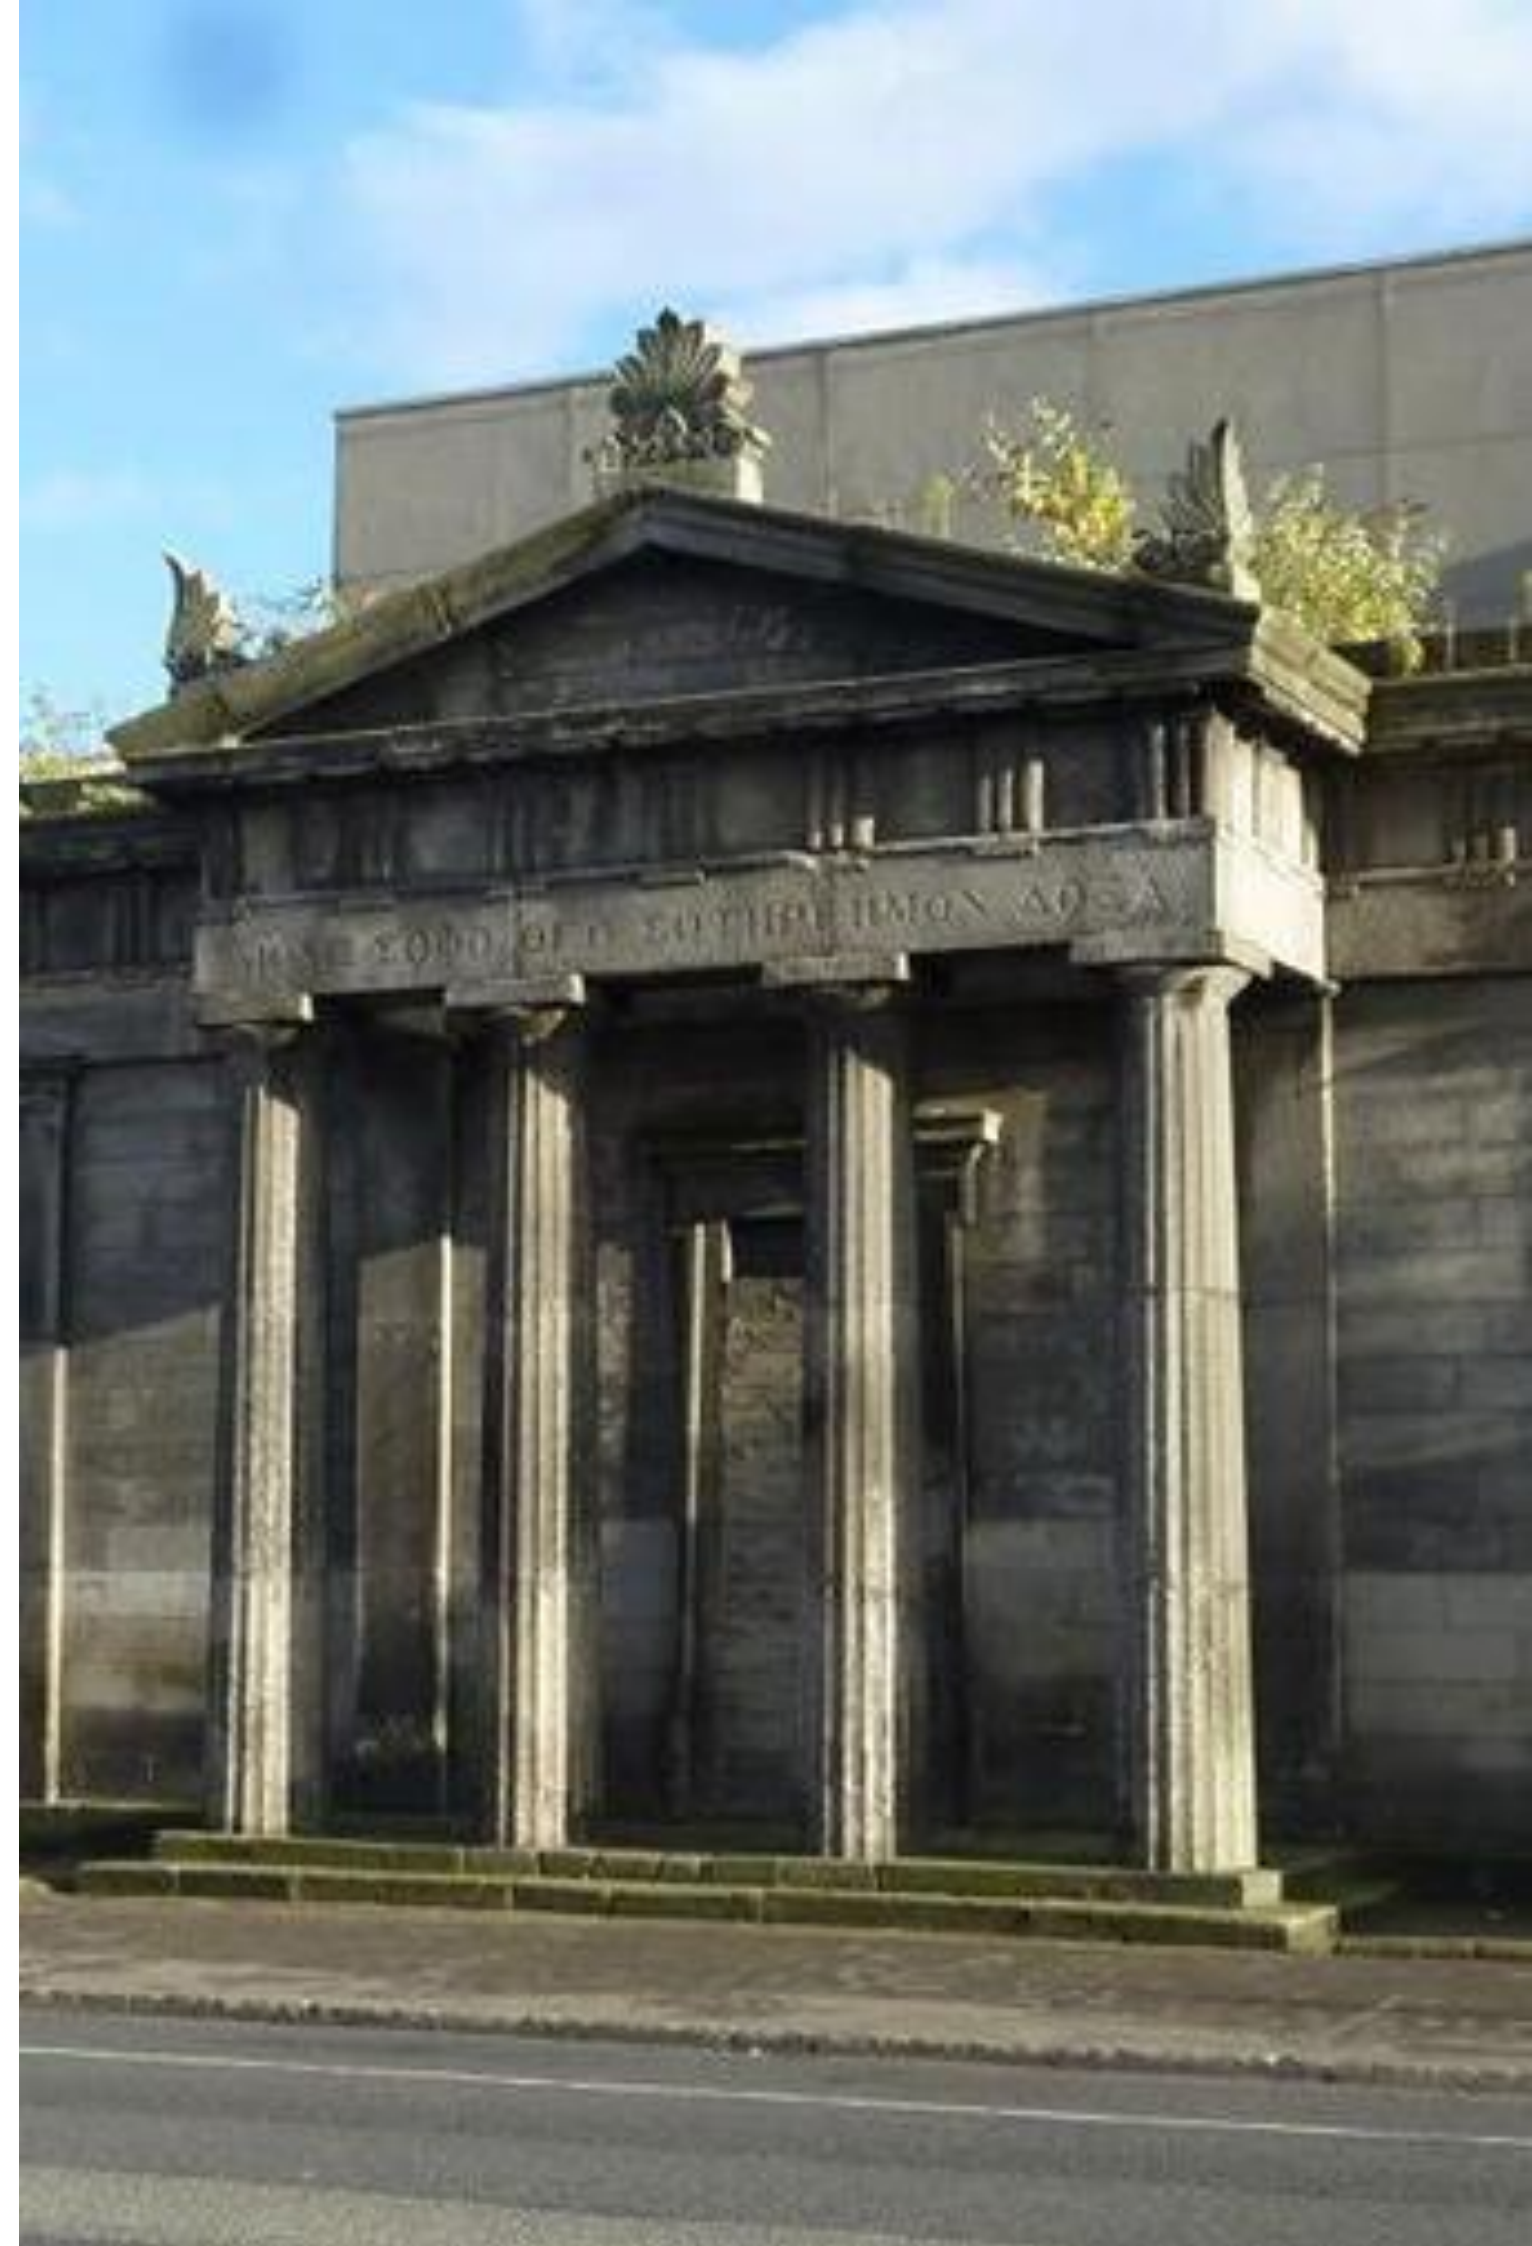
The original building was built for a Presbyterian congregation to the design of a Scottish architect circa 1830, with a small but monumentally proportioned four-columned Doric granite portico with extremely correct use of Grecian motifs. The portico is flanked by wings with severe tapering stone door cases. The church became redundant in the early 20th century and was subsequently used as a grain store. By the 1980s it was vacant and suffered a fire at this time resulting in the loss of the original roof and the subsequent demolition of the main body of the church behind the entrance wall and portico. Failure to provide new flashings and capping on the front wall and around the portico resulted in serious water saturation affecting the stonework. Repair and incorporation of facade within new mixed-use scheme on the 'Convent Lands' site approved 2009 (Refs. 1174/08 / PL29N.231624). With the approved scheme unlikely to proceed in the near future action needs to be taken to arrest further weather damage and deterioration of the stonework.

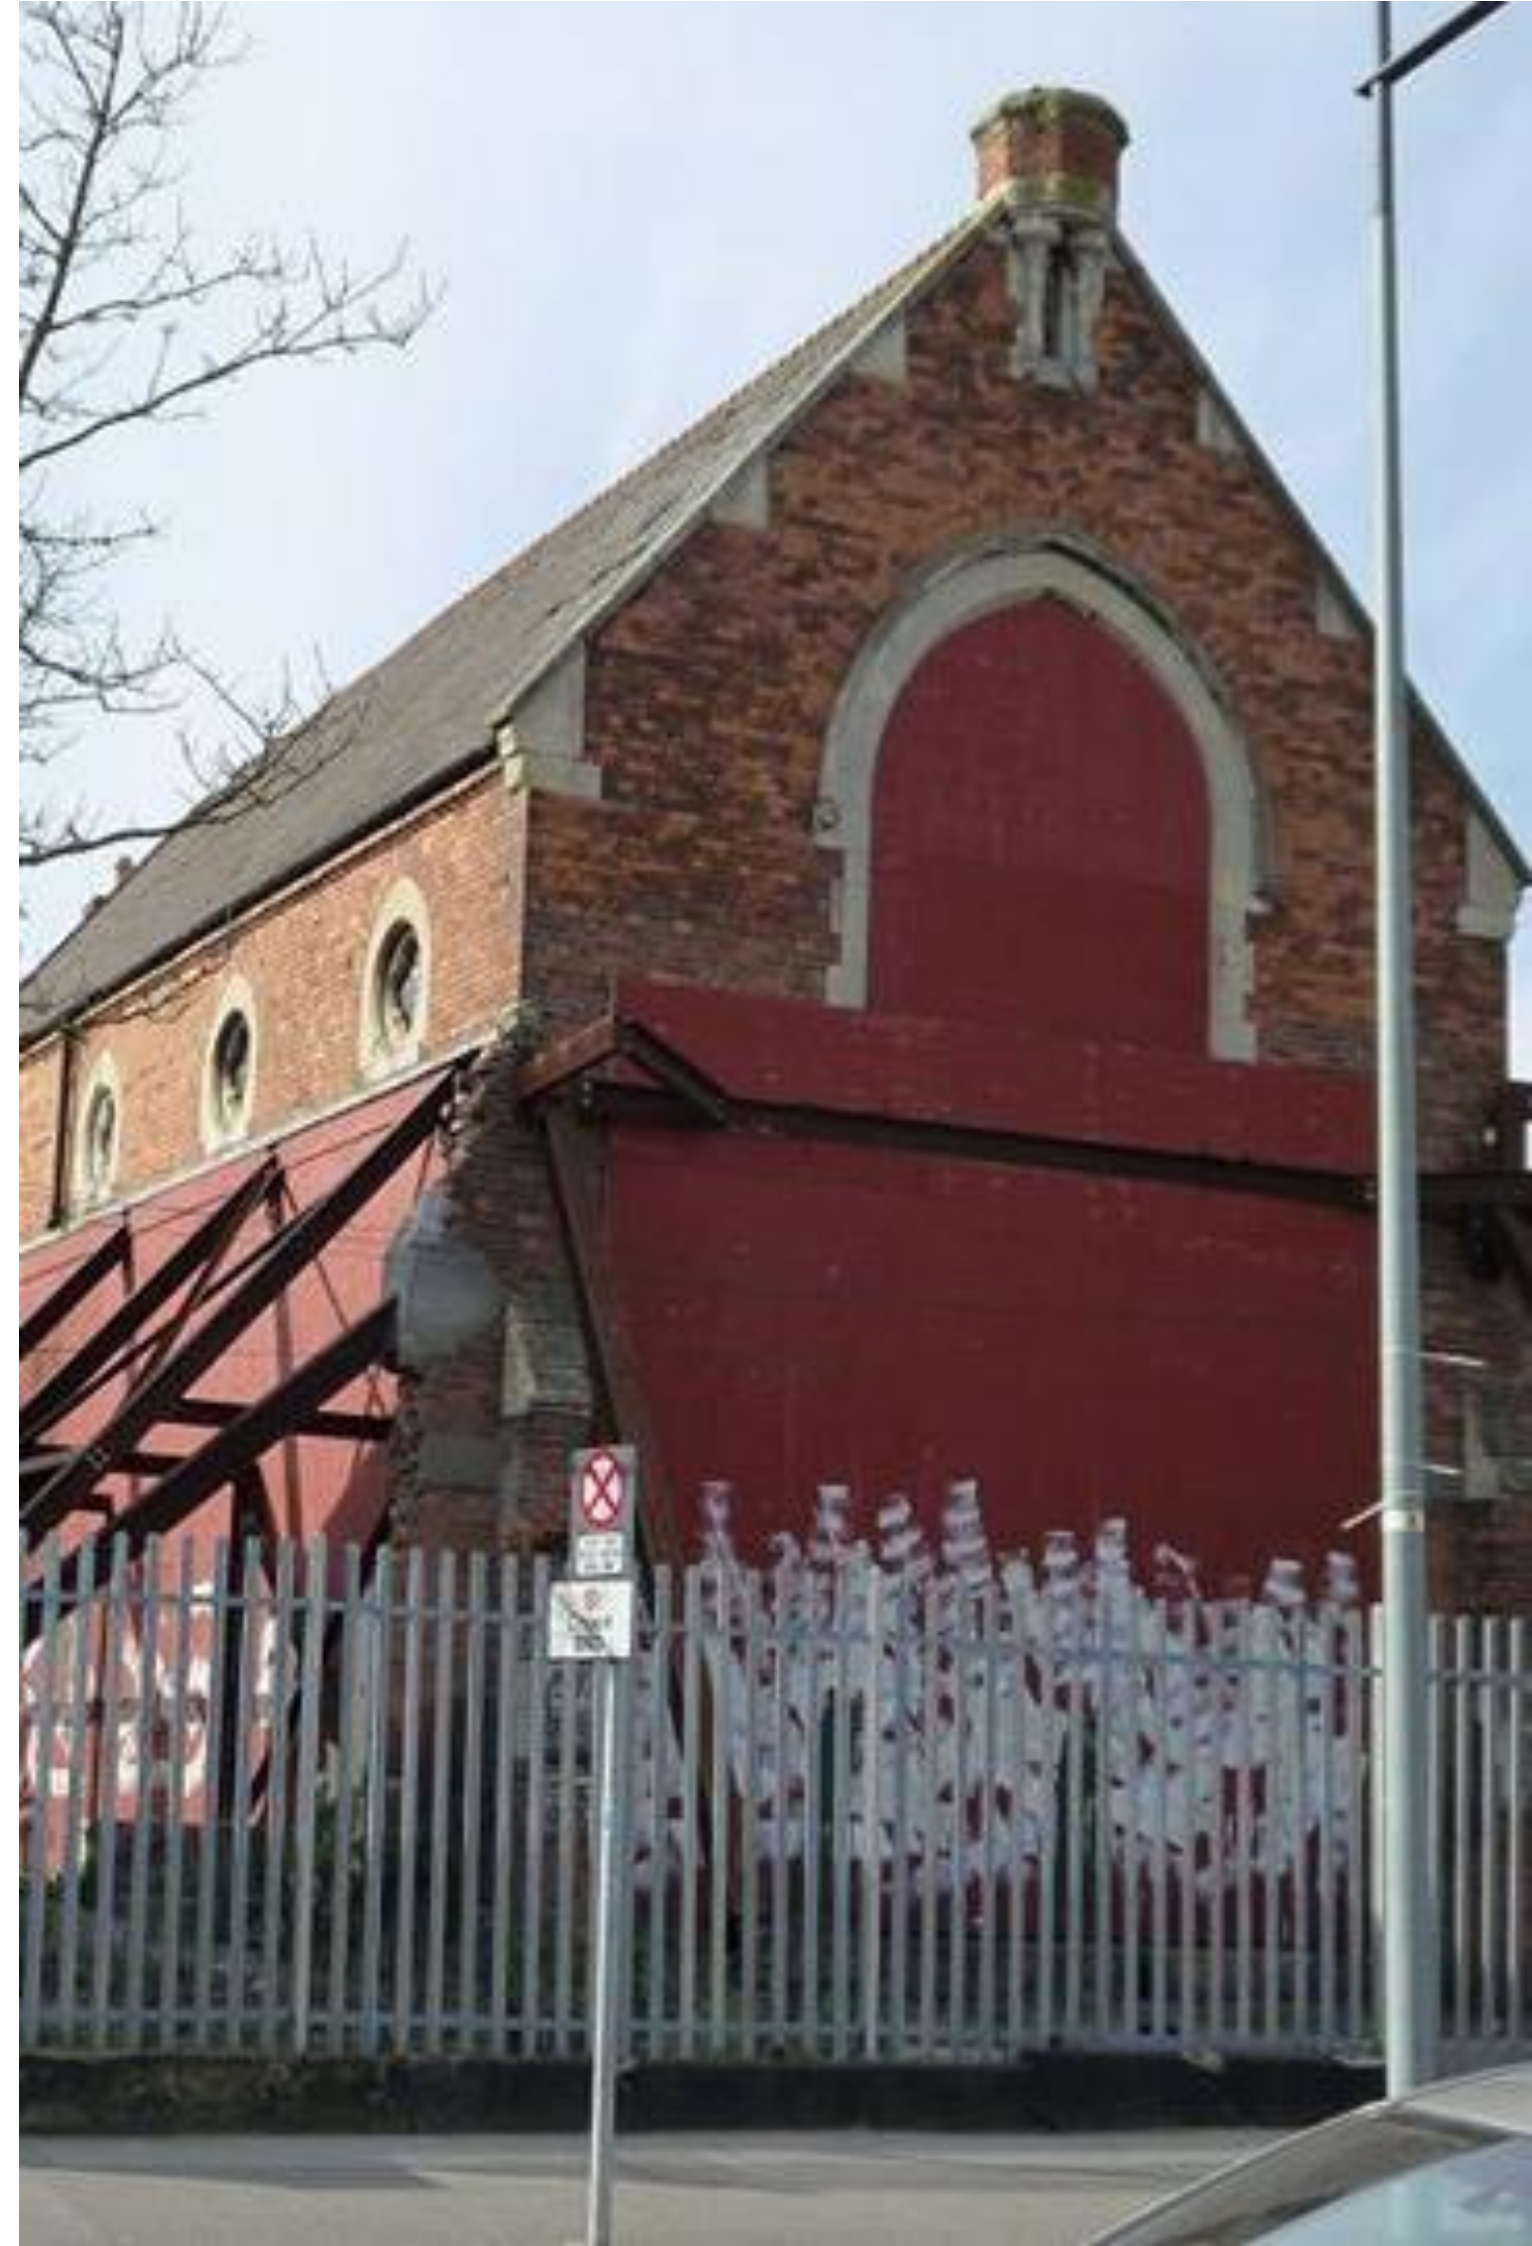
This late 19th century aisle church of red brick construction with stone features and dressings forming a landmark in the adjoining redbrick terraced area, adjoining the railway bridge opposite Croke Park. The building was partially demolished in 2009 with property owner claiming exempted development status by reason of internal sub-divisions, subsequent legal enforcement action remains unresolved. Building is now structurally exposed and infrastructure unresolved. The structure is of significant historic importance and requires conservation works to prevent further deterioration.

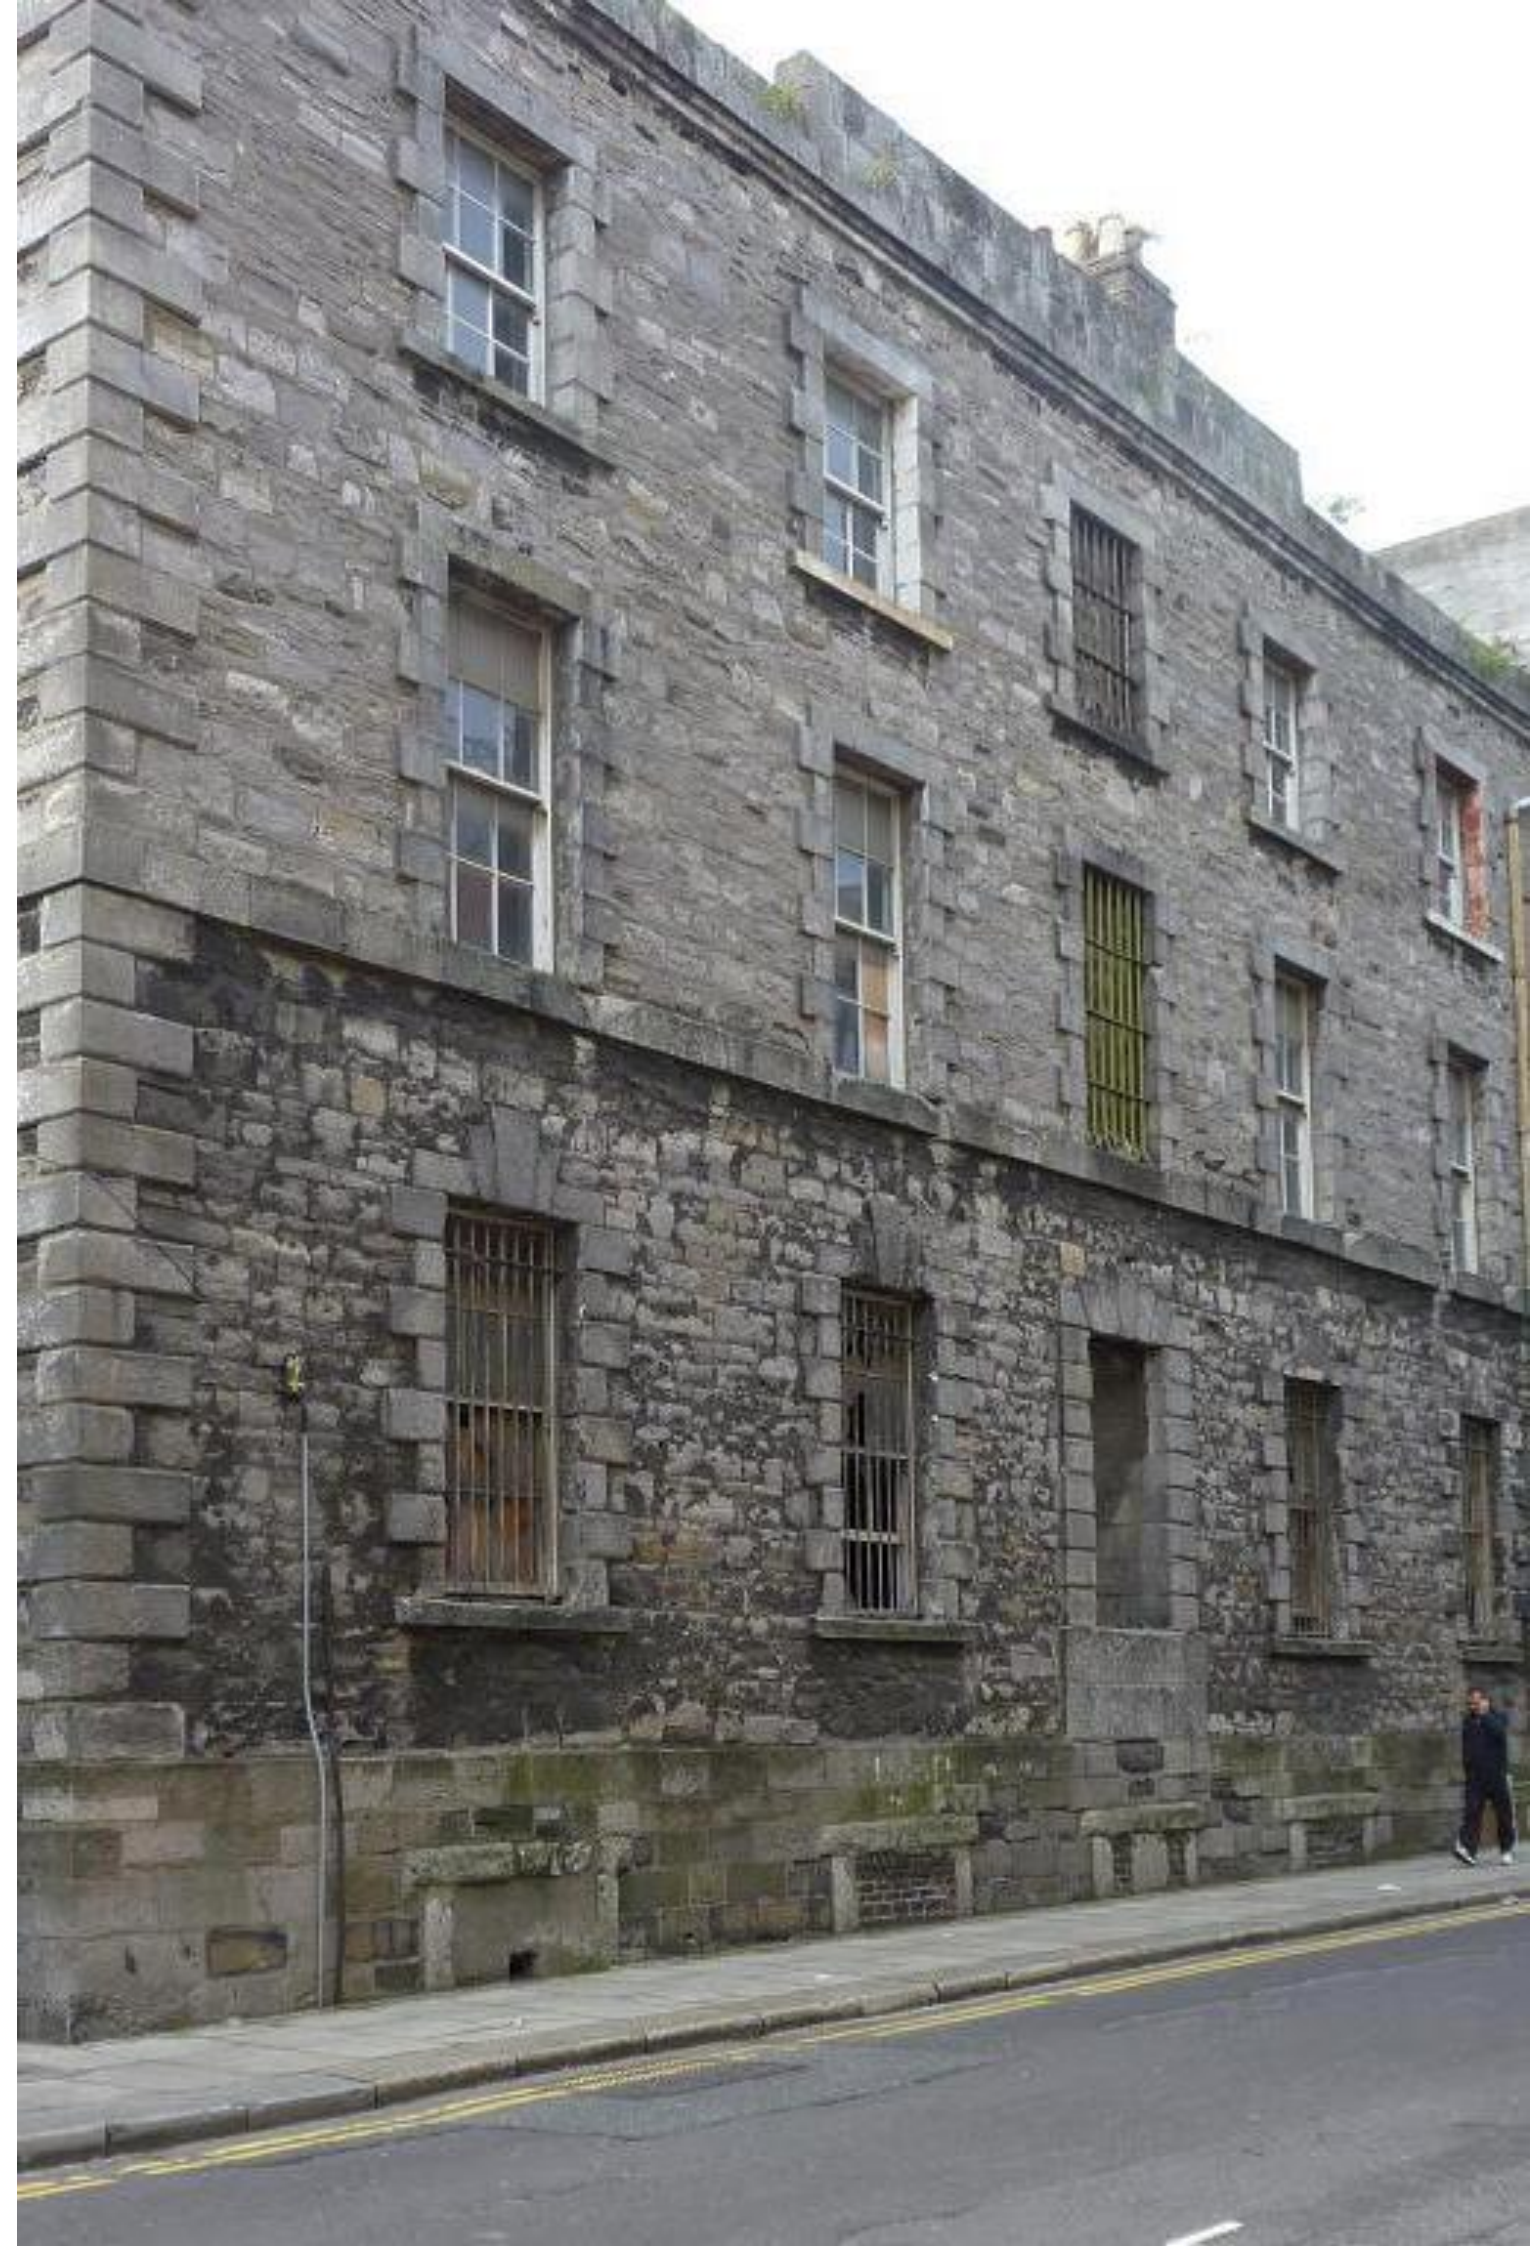
Three-storey over basement U-plan Debtors' Prison of c.1795, built to north side of former City Court and jail complex. The formal elevation is to Green Street. The entrance is from Halston Street through a forecourt. Building leased from the OPW circa 1990 by Green Street Trust with roofing, structural and part interior fit-out works carried out. The scheme was abandoned due to funding and use difficulties. Works carried out in 2011 by OPW in conserving of wall to entrance forecourt in Halston Street. The building is of significant historic importance and requires conservation works to prevent further deterioration.

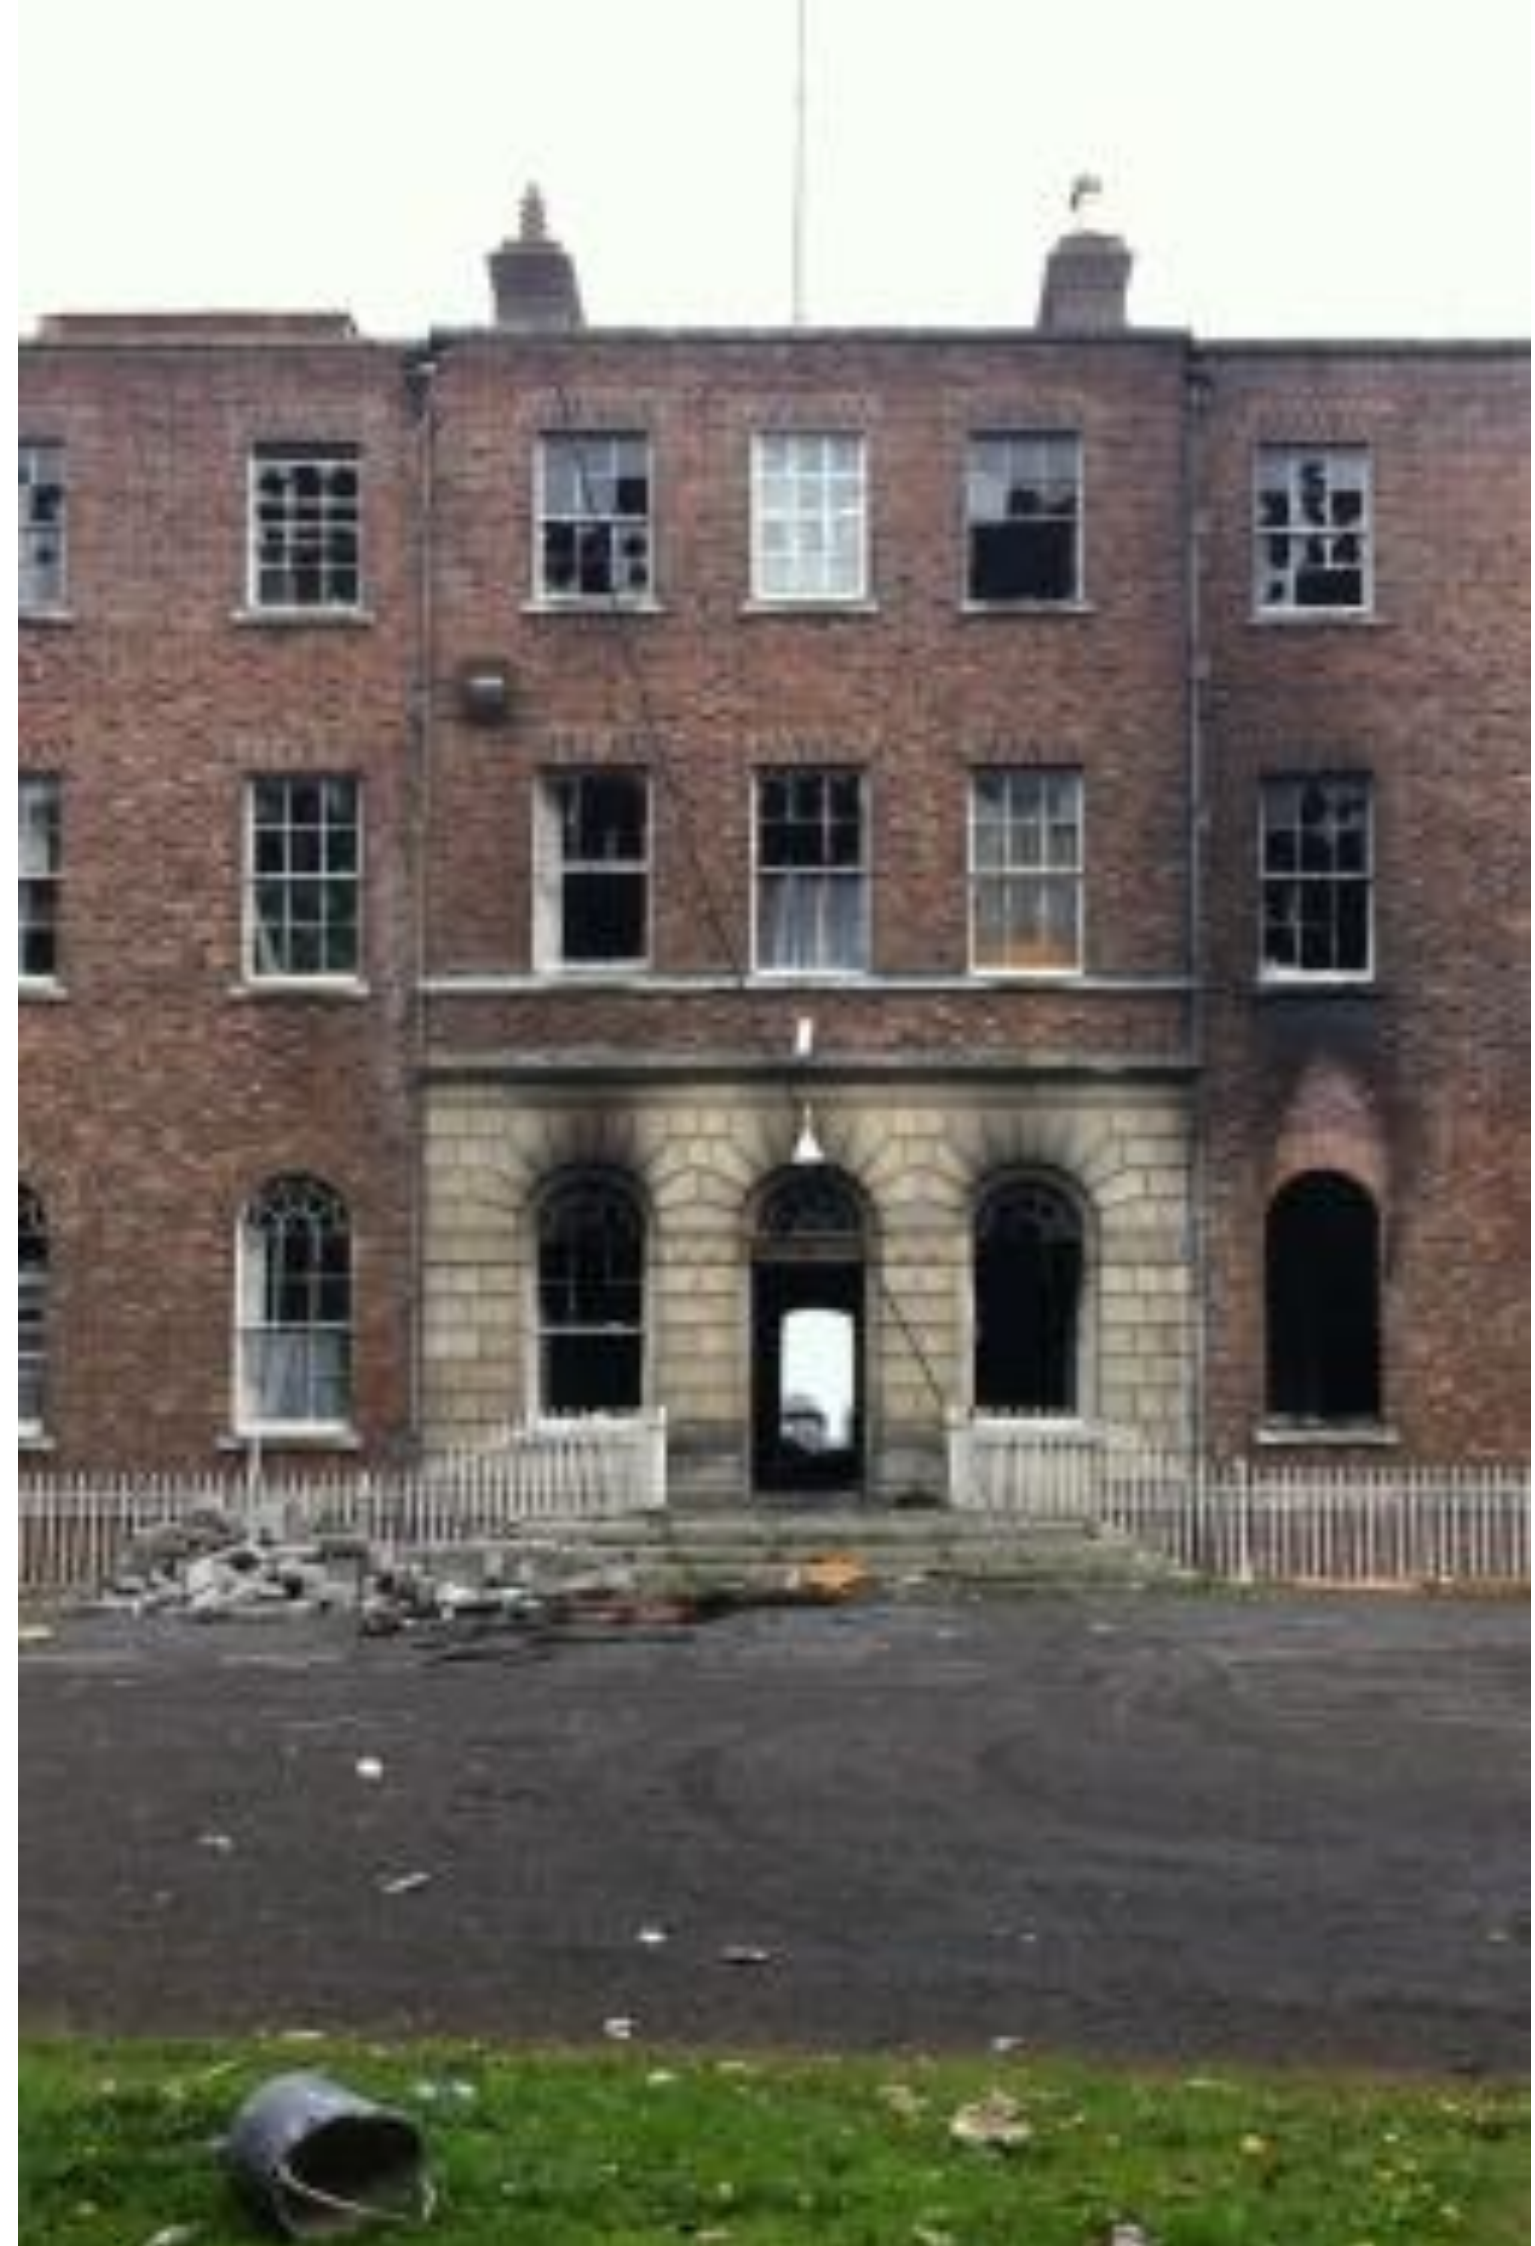
The building is extensively fire damaged and threatened with a real conservation deficit. After it was closed as a school it was taken over by Gannon Ltd and had been left unused since, with Gannon Ltd eventually being put into NAMA. Serious fire damage and theft of materials has occurred. The building is a distinguished late 18th century brick house with significant decorative plasterwork. There were late 19th century institutional buildings added including a chapel with Clarke Studio windows now in off-site storage for safety. This building urgently requires new uses to be identified to prevent further deterioration of its character.

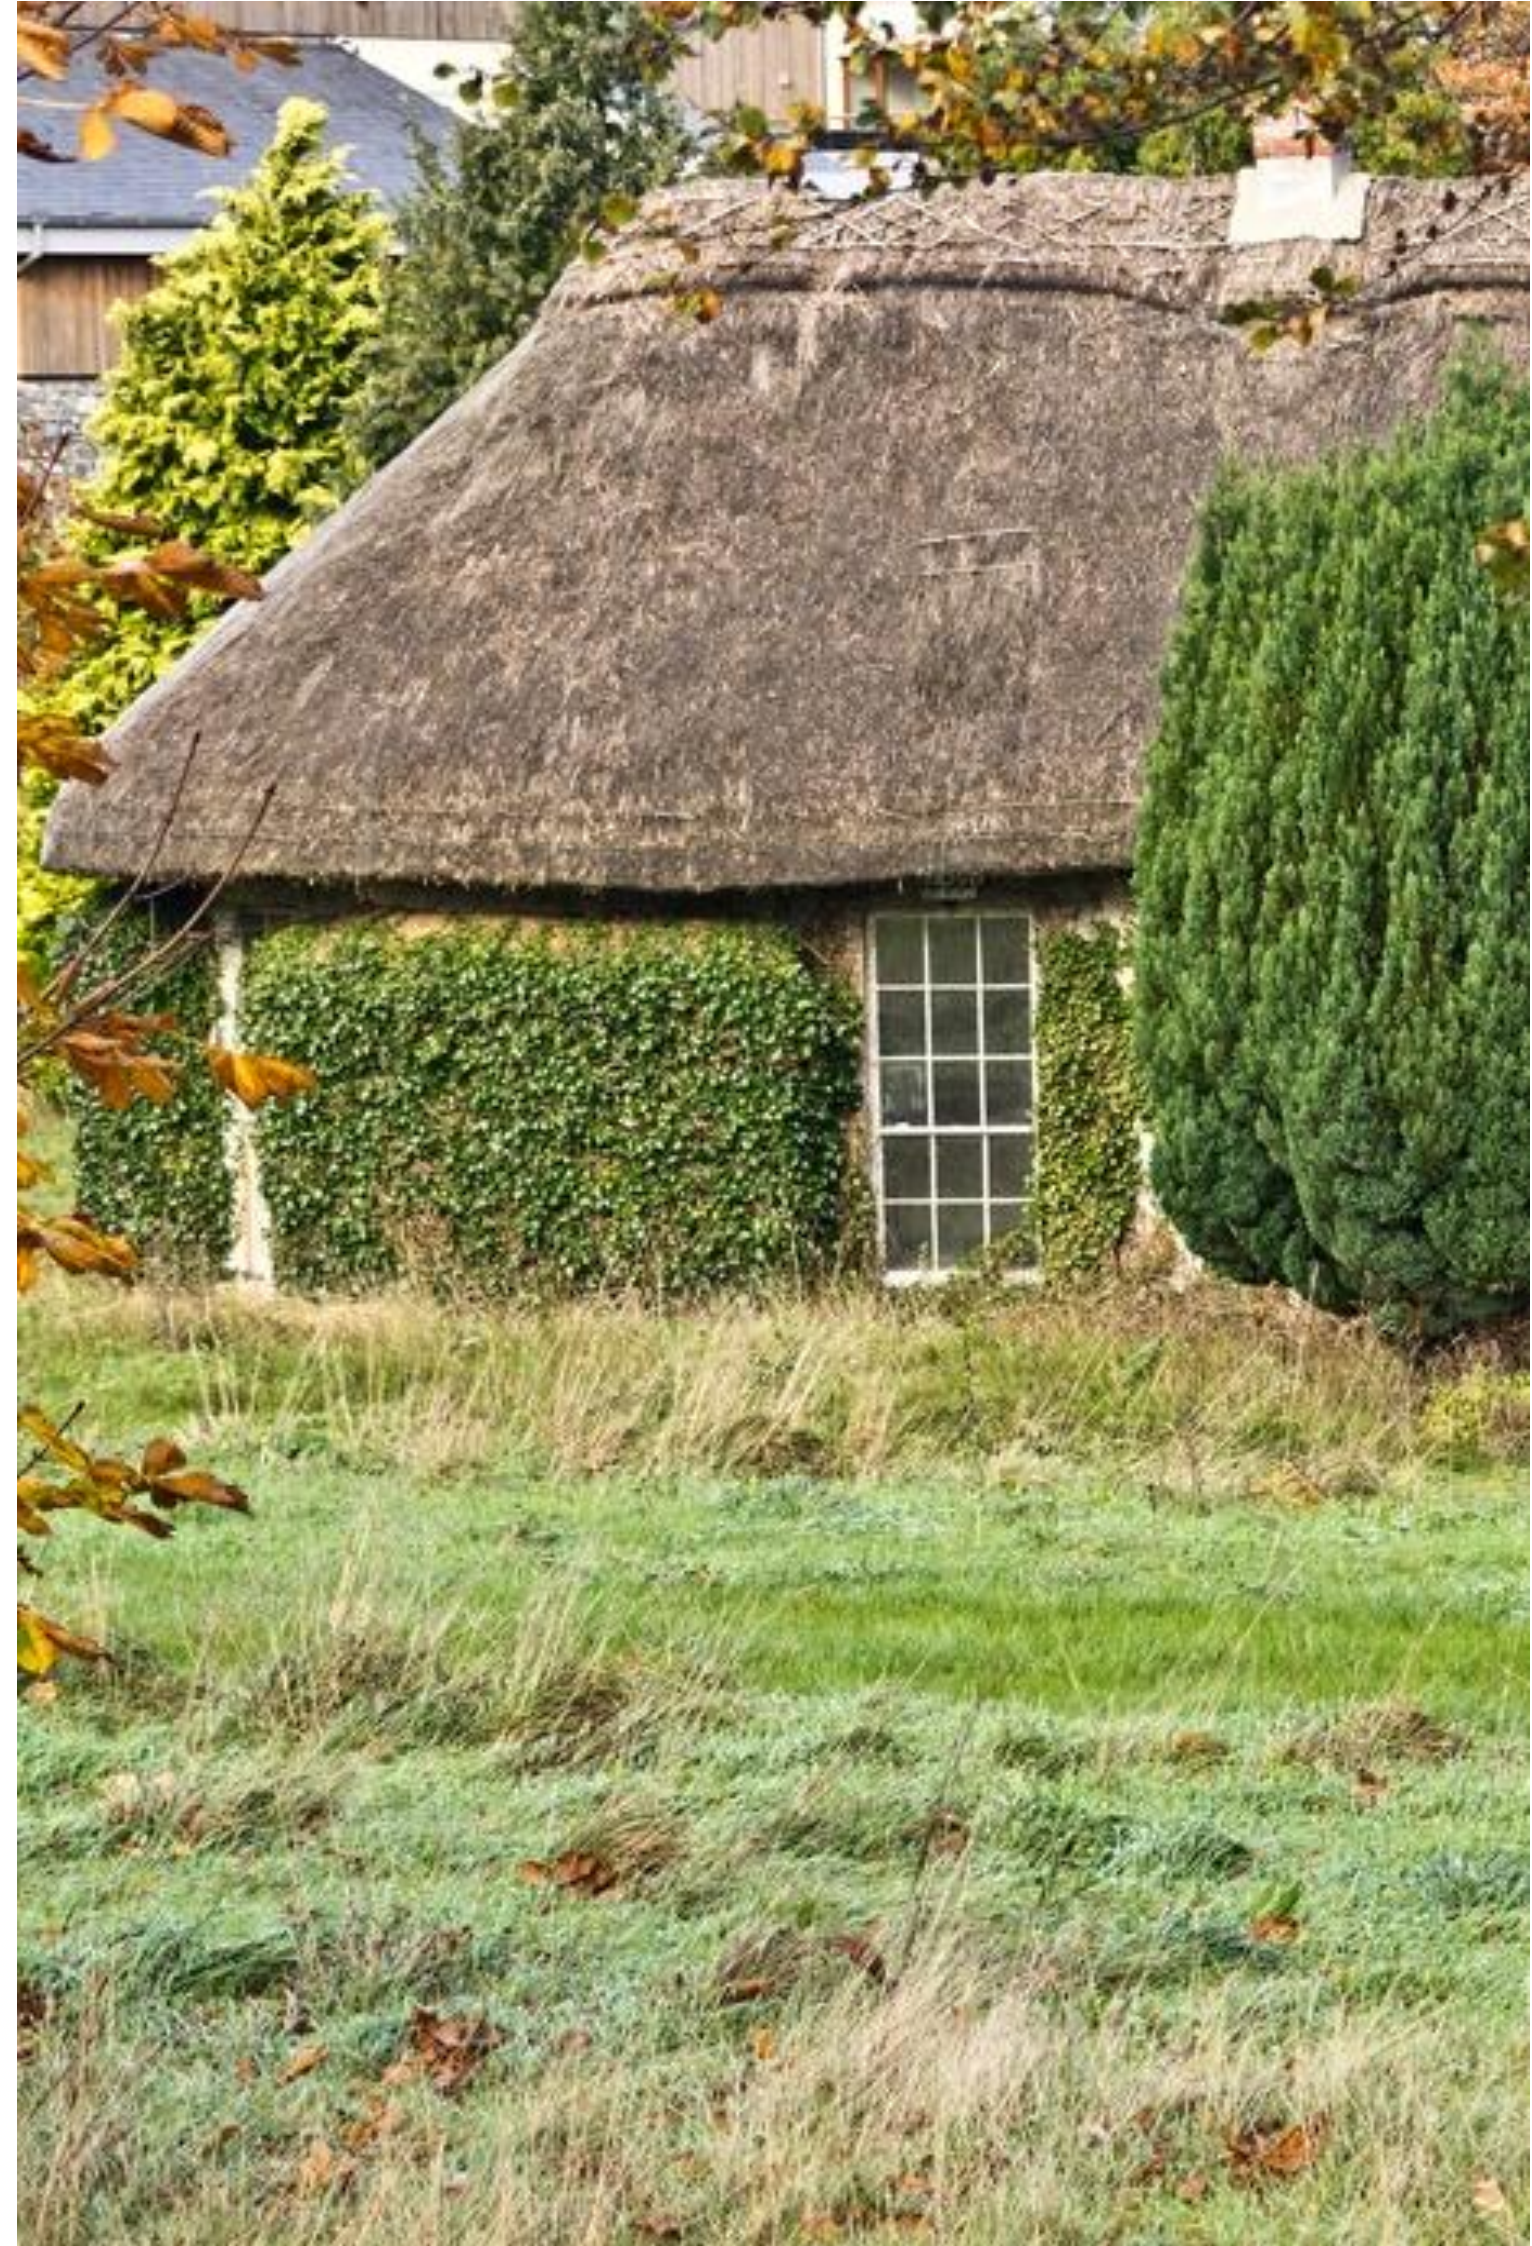
Castle Stables

Vacant with no identified new use	X
Suffering from neglect and/or poor maintenance	X
Suffering from structural problems	X
Fire damaged	
Threatened with demolition	
Ruin which is poorly maintained	X

Condition of Structure	Very Poor
Level of Risk	High

The building is a roofless shell. None of the original fabric remains other than the external walls. It is suffering from structural problems that could lead to full or partial collapse, and there is an immediate threat of further deterioration.

The stables are a complex of outbuildings dating from mid 18th century, located between the now restored castle and Rathfarnham village. It is currently in a derelict condition and undermining the setting of the castle. It should be a priority to secure to prevent further deterioration in a manner that would complement the castle.

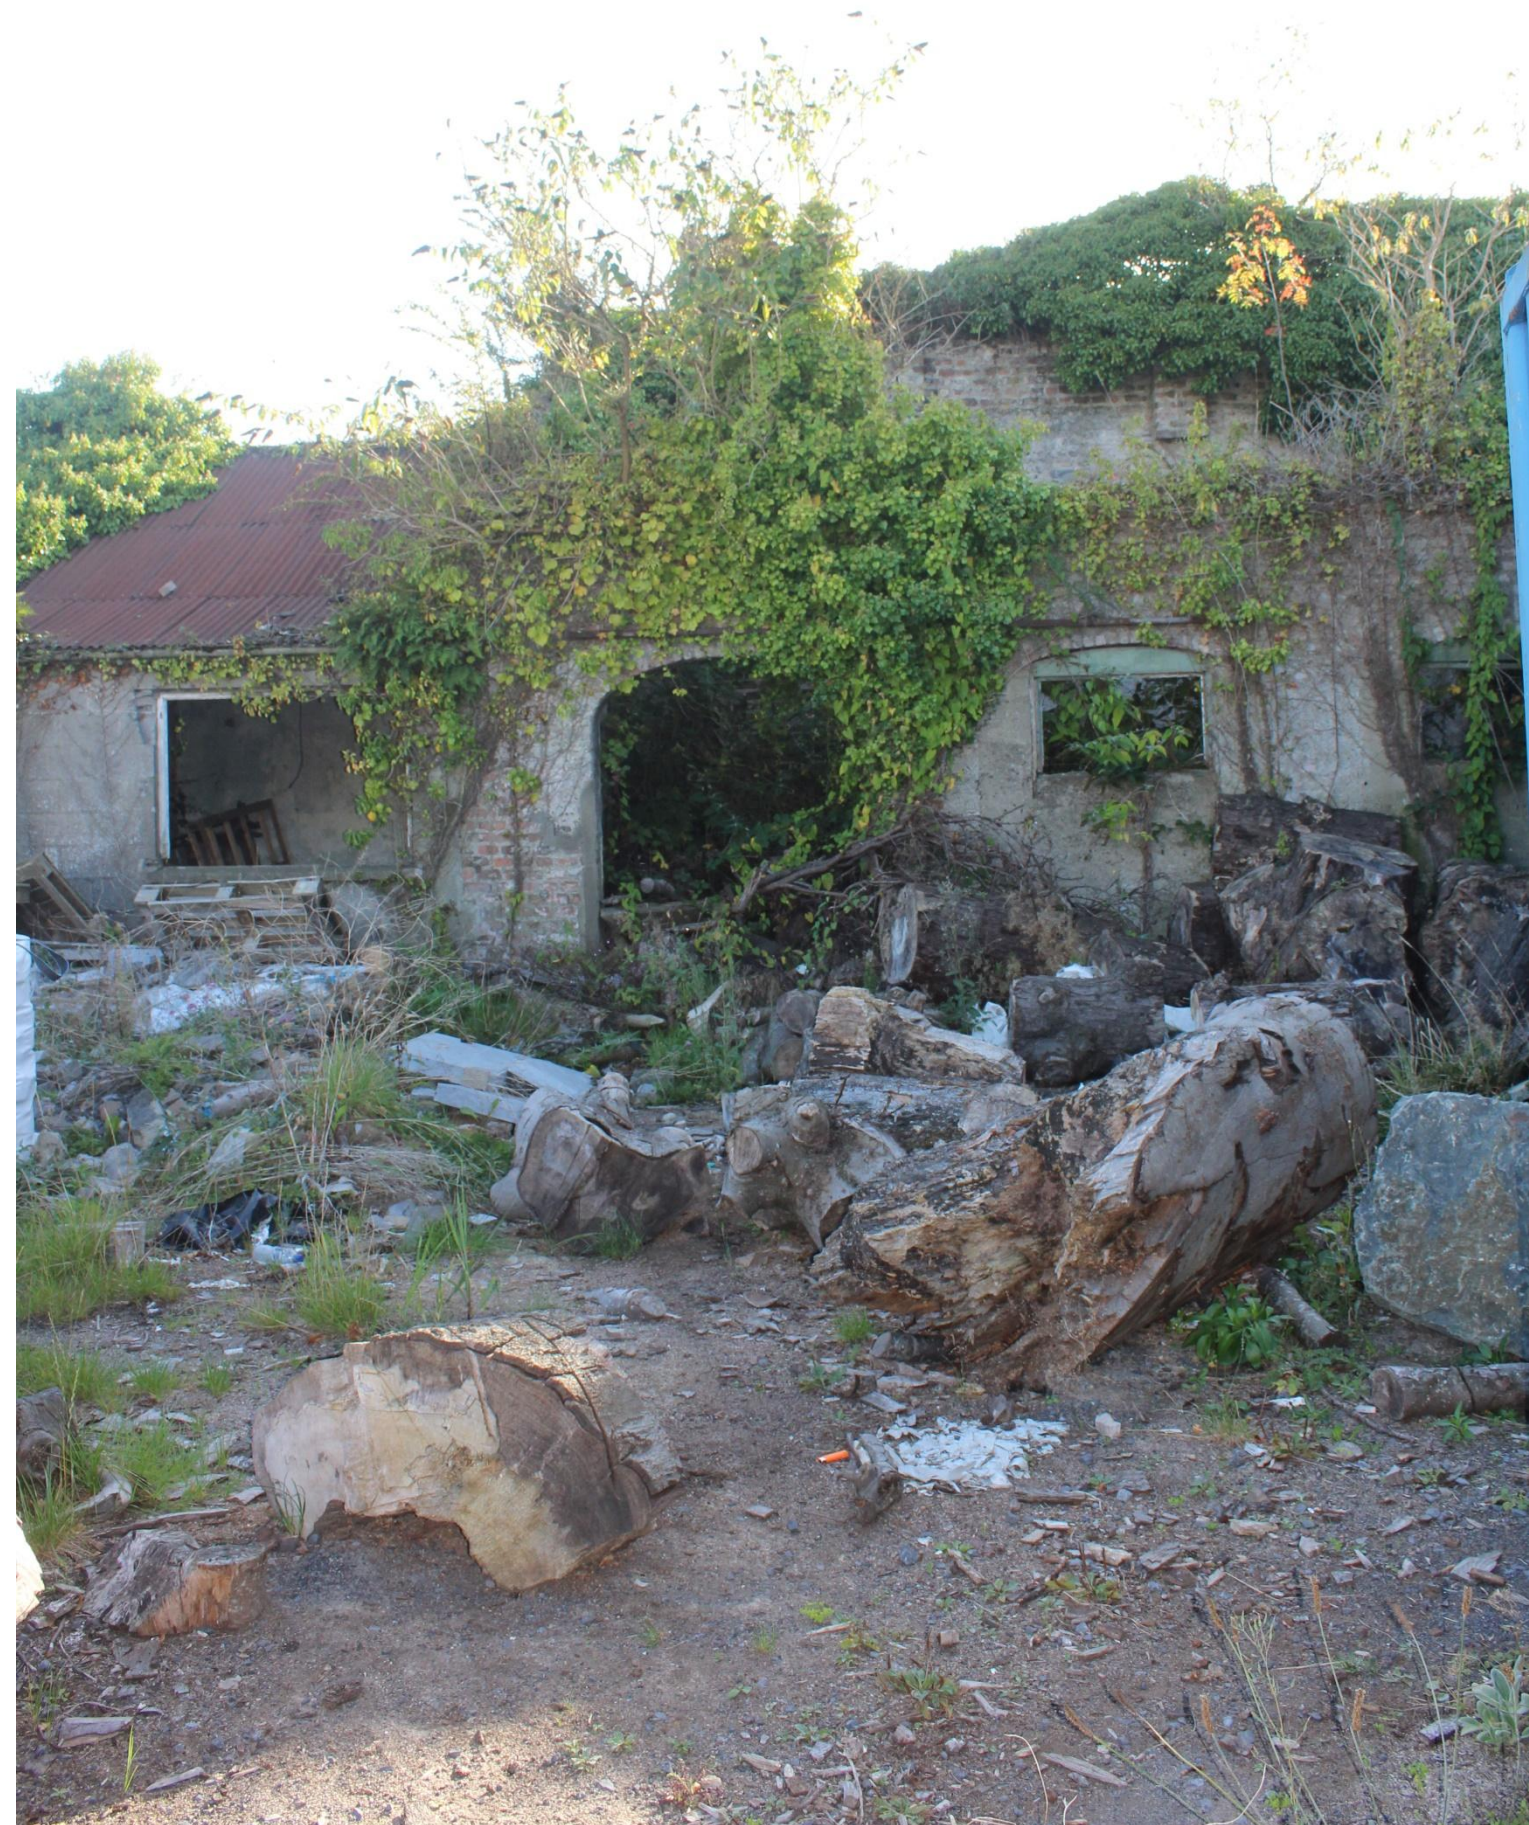
Loreto Abbey

Vacant with no identified new use	X
Suffering from neglect and/or poor maintenance	X
Suffering from structural problems	
Fire damaged	
Threatened with demolition	
Ruin which is poorly maintained

Condition of Structure	Fair
Level of Risk	High

The building is only recently vacant but there is no identified new use. Although previously well maintained, it now requires repairs. There are signs of increasing neglect. There is no immediate danger of collapse but condition is such that unless urgent remedial works are carried out the building will sharply deteriorate.

Within the curtilage of the protected structure, there has been a nursing home and other uses provided as part of major residential development in the grounds. The main structure is a three storey over basement early 18th century brick house, substantially reconstructed in late 20th century, with distinguished entrance hall and room with leather hanging. Following acquisition by the Loreto Order in the 1840s, a chapel was added by Patrick Byrne, with possible design input from Pugin with small scale evocation lantern of Ely Cathedral. Following vacation by Loreto Order major planning permission granted to Zoe development for large scale apartment complex blocks in grounds. Some new uses have been found for portions of the structure. But the building urgently requires a conservation plan to prevent further deterioration of its character.
